**Flood Control Project Maintenance
Levee Inspections**

Maintenance Issue Types Only, Levee Inspection Report By Mile - Spring 2015

Reclamation District No. 0501 Ryer Island

Waterway	Bank	Unit Miles	Inspection Start/End	Inspector
Unit No. 01 Steamboat Slough	Right	6.71	04/08/2015 04/08/2015	Herman Phillips

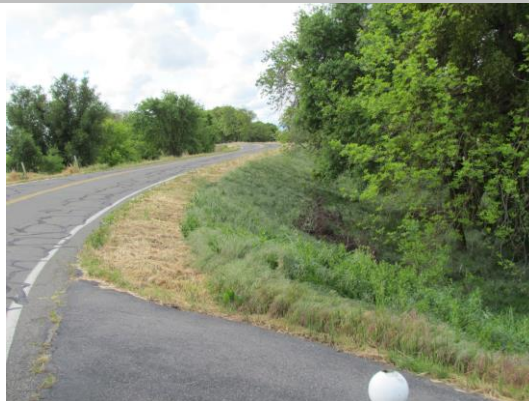
Photo 1 of 1 : SP_2015_RD0501_169_123_20150420_00099.jpg

LM Start	0.26	Rating **	M	Issue No.	123
LM End	1.11	Issue Type +	Ma	Location *	LS
Category	Earthen Levee			GPS Latitude/Longitude	
				Start	End
Item	Vegetation			38.250999 °	38.238869 °
				-121.603126 °	-121.604356 °
DWR ID	DWR_RD0501_01_f_2013_123				
Action/Comments					
Remove the wild growth other than native grasses from the levee slopes.

Looking downstream from landside slope.

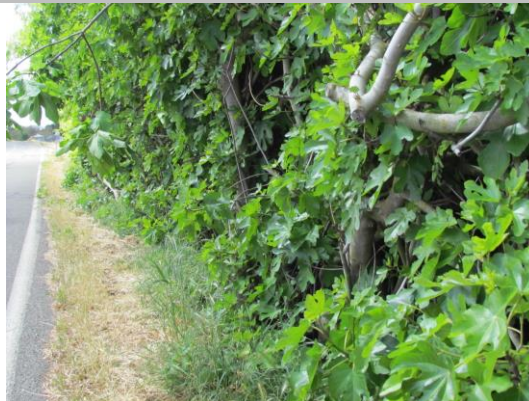
Photo 1 of 1 : SP_2015_RD0501_169_413_20150413_00092.jpg

LM Start	0.27	Rating **	U	Issue No.	413
LM End	0.33	Issue Type +	Ma	Location *	LS
Category	Earthen Levee			GPS Latitude/Longitude	
				Start	End
Item	Trim / Thin Trees			38.250940 °	38.250047 °
				-121.603070 °	-121.603137 °
DWR ID	DWR_RD0501_01_s_2015_413				
Action/Comments					
Trim and thin trees to allow visibility of the ground and room to flood fight.					
Inspector Comments: The district needs to remove the fig trees from the landside levee shoulder and slope.

Unacceptable woody tree growth on landside levee shoulder and slope.

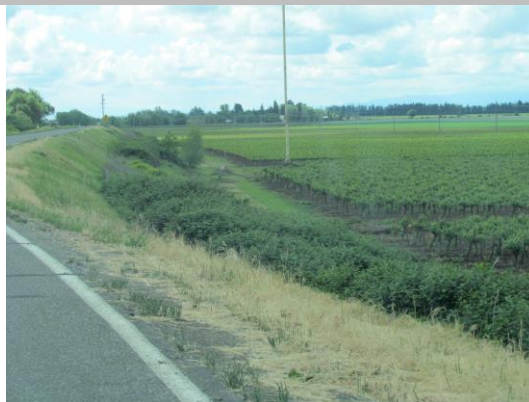
Photo 1 of 1 : SP_2015_RD0501_169_417_20150413_00094.jpg

LM Start	1.55	Rating **	U	Issue No.	417
LM End	1.87	Issue Type +	Ma	Location *	LS
Category	Earthen Levee			GPS Latitude/Longitude	
				Start	End
Item	Vegetation			38.232562 °	38.228025 °
				-121.603473 °	-121.604148 °
DWR ID	DWR_RD0501_01_s _ 2015_417				
Action/Comments					
Remove the wild growth other than native grasses from the levee slopes.					
Inspector Comments: District 501 is aware of the wild growth of berries and are scheduling to have them removed.

Unacceptable growth of wild berries on the land side slope and toe.

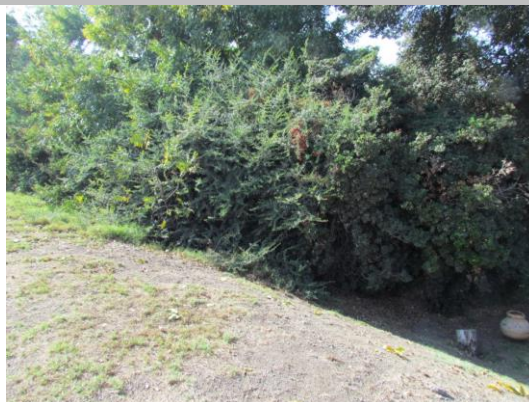
Photo 1 of 1 : SP_2015_RD0501_169_116_20150312_00007.jpg

LM Start	2.31	Rating **	U	Issue No.	116
LM End	2.31	Issue Type +	Ma	Location *	LS
Category	Earthen Levee			GPS Latitude/Longitude	
				Start	End
Item	Trim / Thin Trees			38.221620 °	38.221620 °
				-121.603390 °	-121.603393 °
DWR ID	DWR_RD0501_01_f_2014_116				
Action/Comments					
Trim trees to at least five feet above ground level.					
Inspector Comments: Trim the trees to allow slope to be seen.

Looking downstream at the woody tree growth on the landward levee slope.

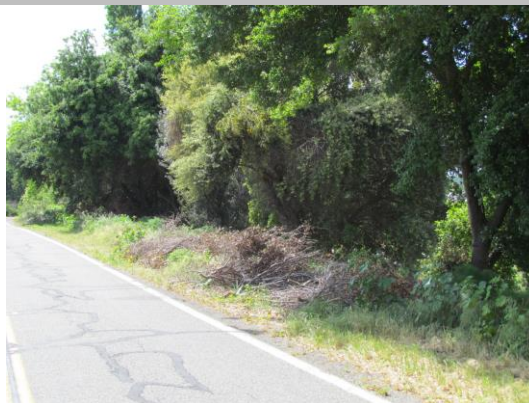
Photo 1 of 1 : SP_2015_RD0501_169_31_20150413_00096.jpg

LM Start	2.38	Rating **	M	Issue No.	31
LM End	3.74	Issue Type +	Ma	Location *	LS
Category	Earthen Levee			GPS Latitude/Longitude	
				Start	End
Item	Vegetation			38.220732 °	38.202810 °
				-121.603734 °	-121.613523 °
DWR ID	DWR_RD0501_01_s_2012_31				
Action/Comments					
Remove the wild growth other than native grasses from the levee slopes.					
Inspector Comments: Remove the wild growth so the levee slope can be seen and inspected.

Wild growth on levee section.

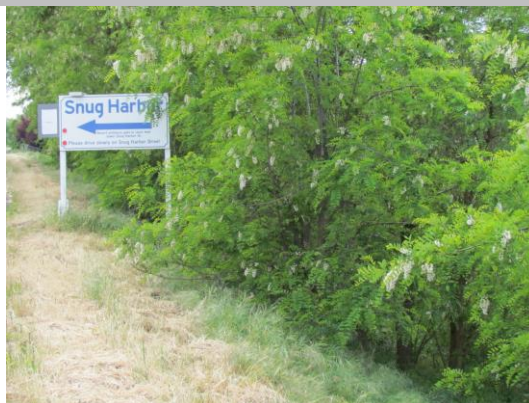
Photo 1 of 1 : SP_2015_RD0501_169_36_20150413_00097.jpg

LM Start	2.84	Rating **	M	Issue No.	36
LM End	3.30	Issue Type +	Ma	Location *	LS
Category	Earthen Levee			GPS Latitude/Longitude	
				Start	End
Item	Vegetation			38.215112 °	38.208925 °
				-121.608273 °	-121.611162 °
DWR ID	DWR_RD0501_01_s_2012_36				
Action/Comments					
Remove the wild growth other than native grasses from the levee slopes.					
Inspector Comments: Remove and or thin so the slope can be inspected. Unable to see the ground under wild tree growth.

Wild growth of black locus trees on levee slope, thin out so levee slope can be seen.

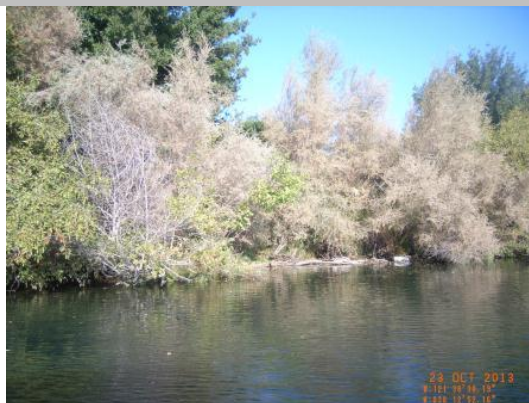
Photo 1 of 1 : SP_2015_RD0501_169_11_20150312_00003.jpg

LM Start	2.85	Rating **	M	Issue No.	11
LM End	2.91	Issue Type +	Ma	Location *	WS
Category	Supplemental			GPS Latitude/Longitude	
				Start	End
Item	USACE Erosion Survey			38.214838 °	38.214075 °
				-121.608129 °	-121.608750 °
DWR ID	DWR_RD0501_01_f_2014_11				
Action/Comments					
Inspector Comments: 2009 - Rock is starting to unravel, probably from a tree pop-out, hard toe. 2013: No observed changes. [2013 Site ID: STM_18-9_R]

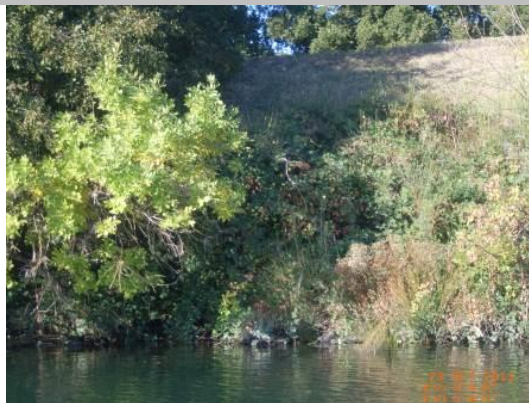
Photo 1 of 1 : SP_2015_RD0501_169_5_20150312_00002.jpg

LM Start	3.04	Rating **	M	Issue No.	5
LM End	3.10	Issue Type +	Ma	Location *	WS
Category	Supplemental			GPS Latitude/Longitude	
				Start	End
Item	USACE Erosion Survey			38.212573 °	38.211596 °
				-121.609760 °	-121.609928 °
DWR ID	DWR_RD0501_01_f_2014_5				
Action/Comments					
Inspector Comments: 2000 - Slow erosion of lower and mid-slope with rock bench at the low water line. 2013: No observed changes. [2013 Site ID: STM_18-8_R]

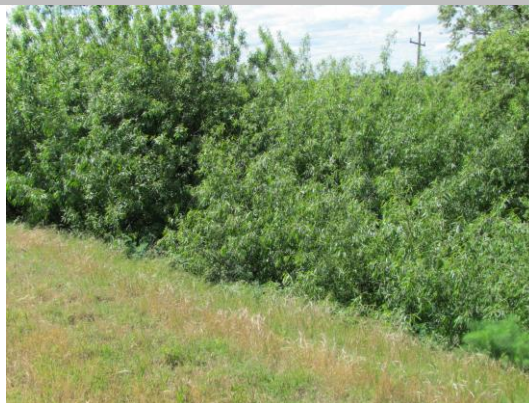
Photo 1 of 1 : SP_2015_RD0501_169_47_20150413_00095.jpg

LM Start	3.59	Rating **	M	Issue No.	47
LM End	3.64	Issue Type +	Ma	Location *	LS
Category	Earthen Levee			GPS Latitude/Longitude	
				Start	End
Item	Trim / Thin Trees			38.204983 °	38.204227 °
				-121.612868 °	-121.613045 °
DWR ID	DWR_RD0501_01_s _ 2012_47				
Action/Comments					
Trim and thin trees to allow visibility of the ground and room to flood fight.					
Inspector Comments: Not able to see levee slope.

Wild tree growth on landside slope and shoulder should be trimmed and thinned.

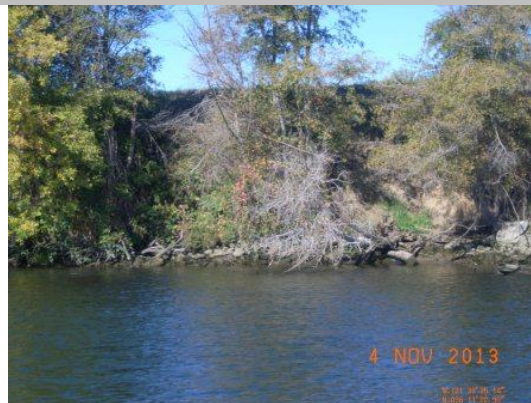
Photo 1 of 1 : SP_2015_RD0501_169_3_20150312_00001.jpg

LM Start	5.77	Rating **	M	Issue No.	3
LM End	5.84	Issue Type +	Ma	Location *	WS
Category	Supplemental			GPS Latitude/Longitude	
				Start	End
Item	USACE Erosion Survey			38.190001 °	38.189311 °
				-121.643160 °	-121.643917 °
DWR ID	DWR_RD0501_01_f_2014_3				
Action/Comments					
Inspector Comments: 2008 - Overstepped levee section with multiple small pockets of erosion 10 - 20 ft wide. 2013: Site has fresh erosion and taller vertical sections. [2013 Site ID: STM_15-7_R]

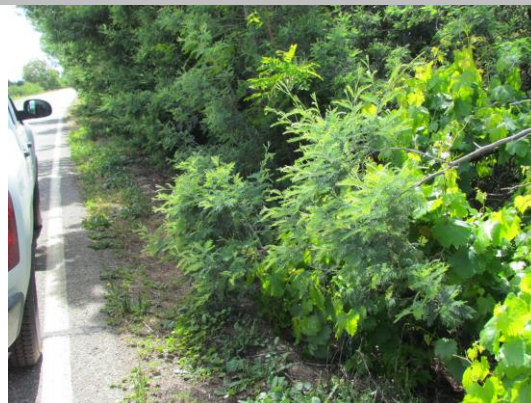
Photo 1 of 1 : SP_2015_RD0501_169_20_20150420_00101.jpg

LM Start	5.88	Rating **	M	Issue No.	20
LM End	6.17	Issue Type +	Ma	Location *	LS
Category	Earthen Levee			GPS Latitude/Longitude	
				Start	End
Item	Vegetation			38.188929 °	38.185941 °
				-121.644645 °	-121.648359 °
DWR ID	DWR_RD0501_01_s_2012_20				
Action/Comments					
Remove the wild growth other than native grasses from the levee slopes.					
Inspector Comments: Remove the wild growth from the levee section.					
Can't see the slope.

Looking downstream from landside slope unacceptable wild growth on the landward shoulder and slope.

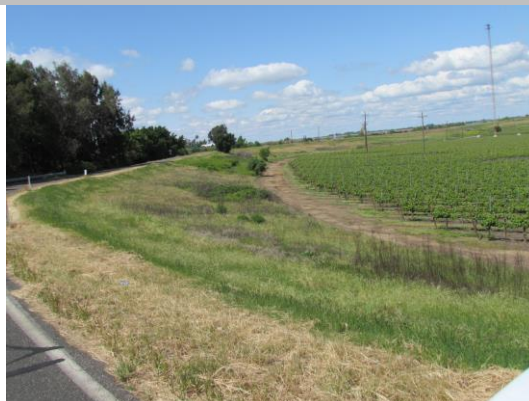
Photo 1 of 1 : SP_2015_RD0501_170_21_20150420_00035.jpg

LM Start	0.00	Rating **	M	Issue No.	21
LM End	0.00	Issue Type +	Ma	Location *	LS
Category	Earthen Levee			GPS Latitude/Longitude	
				Start	End
Item	Vegetation			38.188260 °	38.188260 °
				-121.648701 °	-121.648700 °
DWR ID	DWR_RD0501_02_s_2012_21				
Action/Comments					
Remove the wild growth other than native grasses from the levee slopes.

Looking downstream along the landside levee slope.

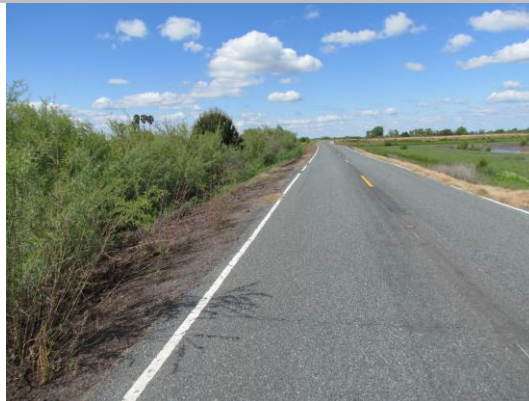
Photo 1 of 1 : SP_2015_RD0501_170_11_20150420_00037.jpg

LM Start	0.54	Rating **	M	Issue No.	11
LM End	0.54	Issue Type +	Ma	Location *	WS
Category	Earthen Levee			GPS Latitude/Longitude	
				Start	End
Item	Trim / Thin Trees			38.191117 °	38.191170 °
				-121.656468 °	-121.656437 °
DWR ID	DWR_RD0501_02_s_2012_11				
Action/Comments					
Trim and thin trees to allow visibility of the ground and room to flood fight.					
Inspector Comments: Remove the young willow trees from the levee slope.

Wild growth on the waterside levee slope.

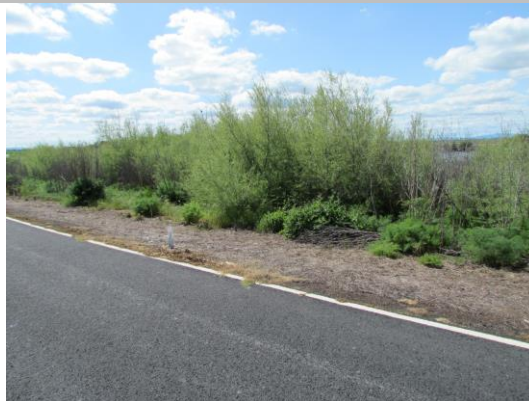
Photo 1 of 1 : SP_2015_RD0501_170_8_20150420_00038.jpg

LM Start	1.07	Rating **	M	Issue No.	8
LM End	1.11	Issue Type +	Ma	Location *	WS
Category	Earthen Levee			GPS Latitude/Longitude	
				Start	End
Item	Vegetation			38.198602 °	38.199148 °
				-121.655605 °	-121.655490 °
DWR ID	DWR_RD0501_02_s_2012_8				
Action/Comments					
Remove the wild growth other than native grasses from the levee slopes.					
Inspector Comments: Remove the unacceptable growth from the waterside slope.

Unacceptable wild growth on the water side levee slope.

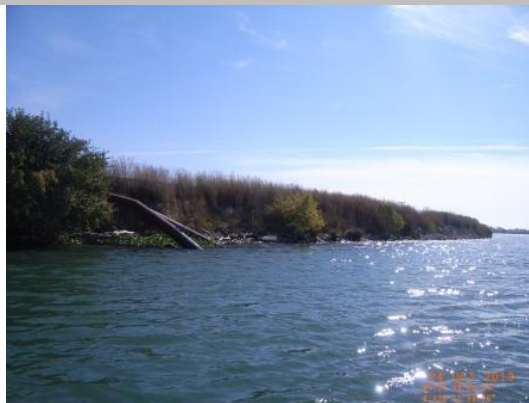
Photo 1 of 1 : SP_2015_RD0501_170_5_20150312_00001.jpg

LM Start	1.10	Rating **	M	Issue No.	5
LM End	1.17	Issue Type +	Ma	Location *	WS
Category	Supplemental			GPS Latitude/Longitude	
				Start	End
Item	USACE Erosion Survey			38.199128 °	38.200146 °
				-121.655881 °	-121.655638 °
DWR ID	DWR_RD0501_02_f_2014_5				
Action/Comments					
Inspector Comments: 2005 - Large vertical sections due to wave wash. New stone dumped on the bank with exposed geotextile. Cohesive toe has thin weak stratigraphic unit that is washing out. 2006 - Partially repaired, but 100 ft in the middle of the reach has exposed filter fabric and stone riprap is gone. 2010 - Site extended downstream to include new erosion pocket. 2013: No observed changes. [2013 Site ID: CHS_15-9_L]

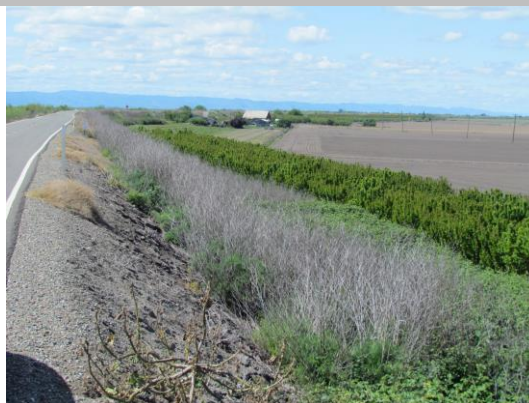
Photo 1 of 1 : SP_2015_RD0501_170_1_20150420_00039.jpg

LM Start	1.51	Rating **	M	Issue No.	1
LM End	2.68	Issue Type +	Ma	Location *	LS
Category	Earthen Levee			GPS Latitude/Longitude	
				Start	End
Item	Vegetation			38.204957 °	38.216130 °
				-121.655087 °	-121.667686 °
DWR ID	DWR_RD0501_02_f_2012_1				
Action/Comments					
Remove the wild growth other than native grasses from the levee slopes.					
Inspector Comments: Remove the tall weeds from the landward levee section.

Unacceptable tall weeds on the landward levee section.

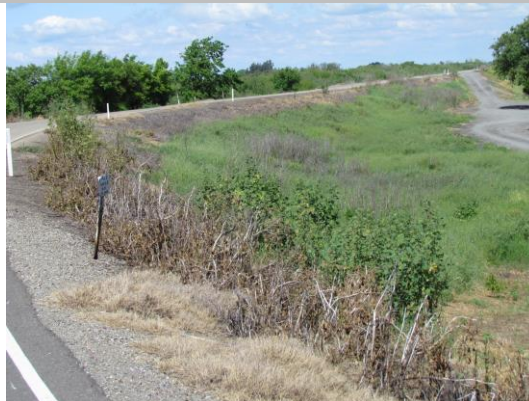
Photo 1 of 1 : SP_2015_RD0501_171_1_20150604_00069.jpg

LM Start	0.01	Rating **	U	Issue No.	1
LM End	0.90	Issue Type +	Ma	Location *	LS
Category	Earthen Levee			GPS Latitude/Longitude	
				Start	End
Item	Vegetation			38.227815 °	38.238702 °
				-121.673129 °	-121.664900 °
DWR ID	DWR_RD0501_03_s_2012_1				
Action/Comments					
Remove the wild growth other than native grasses from the levee slopes.					
Inspector Comments: Remove the unwanted tall weeds from the landside slope.

View looking downstream along the landside shoulder.

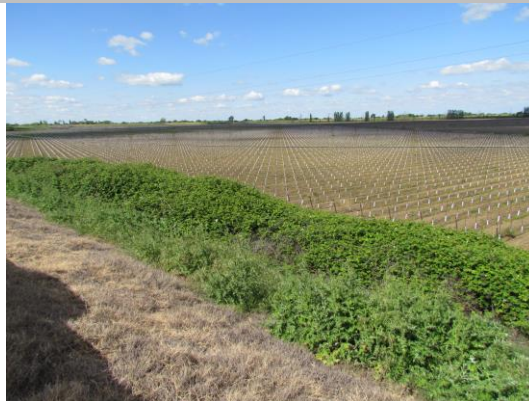
Photo 1 of 1 : SP_2015_RD0501_171_430_20150604_00070.jpg

LM Start	4.57	Rating **	U	Issue No.	430
LM End	5.00	Issue Type +	Ma	Location *	LS
Category	Earthen Levee			GPS Latitude/Longitude	
				Start	End
Item	Vegetation			38.279153 °	38.283603 °
				-121.638700 °	-121.643350 °
DWR ID	DWR_RD0501_03_s _ 2015_430				
Action/Comments					
Control annual grass and weeds on the levee slopes and easements. Inspector Comments: Remove the wild berries from the levee section.

Looking downstream at the landside the slope and toe covered with unacceptable wild growth.

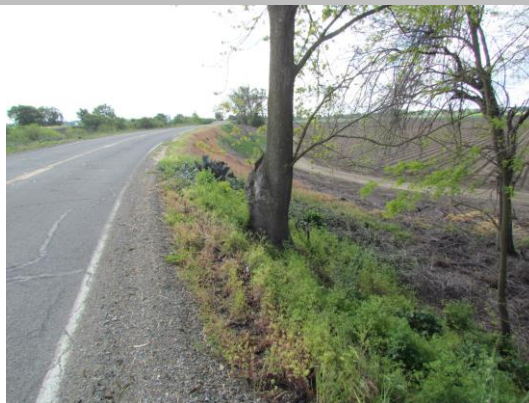
Photo 1 of 1 : SP_2015_RD0501_172_3_20150604_00045.jpg

LM Start	0.01	Rating **	M	Issue No.	3
LM End	0.04	Issue Type +	Ma	Location *	LS
Category	Earthen Levee			GPS Latitude/Longitude	
				Start	End
Item	Vegetation			38.285529 °	38.285074 °
				-121.606258 °	-121.605489 °
DWR ID	DWR_RD0501_04_f_2012_3				
Action/Comments					
Remove the wild growth other than native grasses from the levee slopes.					
Inspector Comments: Control the vegetation on the landside slope.

View looking downstream from the landside shoulder.
